# Conservation of the Old Parliament House Feature Windows

Emma Gwynn and Doug Rogan

## **Conservation of the Old Parliament House Feature Windows**

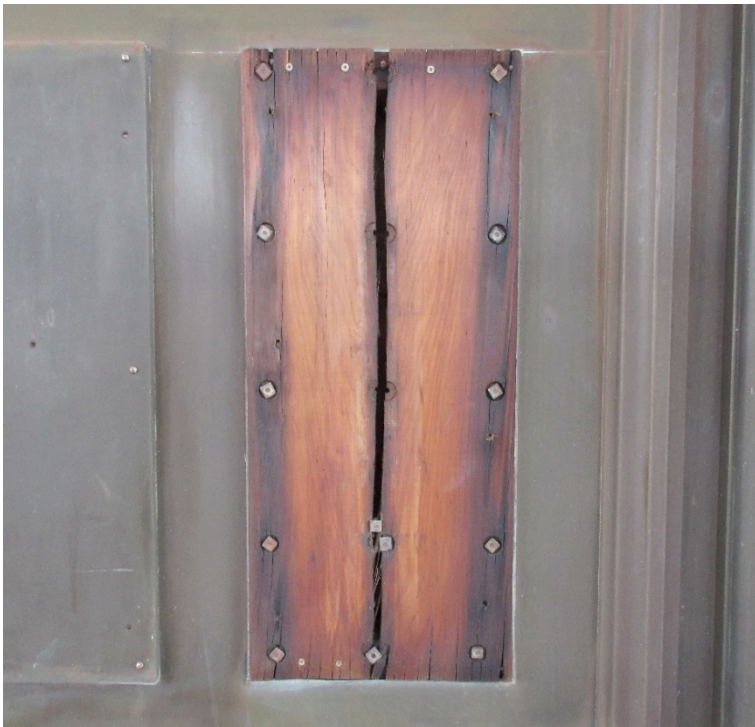
The central copper alloy panels were removed, and in nearly all cases the timber behind was replaced with marine ply. One exception to this was for window WA5, proper lhs panel, where the original timber and some original fastenings were evident, and the timber was still serviceable despite suffering some previous damage (See Figure 3). In replacing the copper alloy panels original screw holes were used but the screws were replaced with new brass, domed, slot-head screws, patinated to match the copper alloy façade. The copper alloy panels had the corners repaired by cleaning off old solder and gluing back into place using the sealant. The entire panel was then reattached using the screws, and sealed using a fine bead of sealant along the top edge and down both sides. The bottom was left unsealed to provide an exit point for moisture that might get into the section.

**Figure 3.** Original backing board on window WA5, proper lhs, segment 3/5.
