Architectural Heritage under Threat:

- Disaster and the Conservation Difficulty, Using Kinmen Island as a Case Study •••••

Department of Architecture, National Quemoy University, Taiwan

Suva, Fiji, 1–5 October 2018

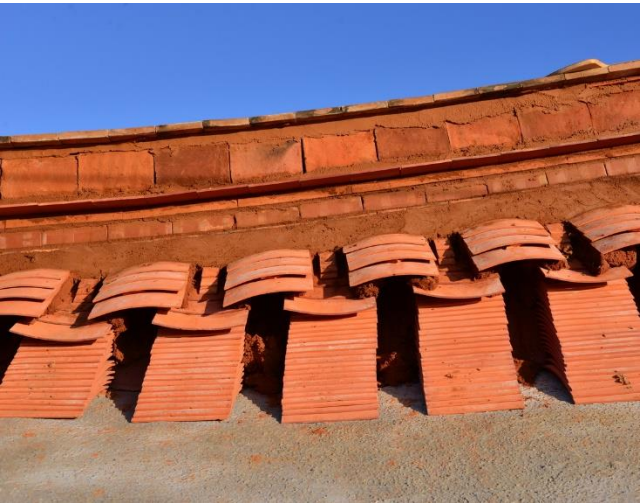
- ❖ Kinmen's traditional architecture is characterised by red tile roofing and wooden structural frames.
- ❖ The walls are made of bricks or blocks that combine.
- ❖ Without sufficient maintenance, leakage and termite infestation become a common sight.

red tile roofing

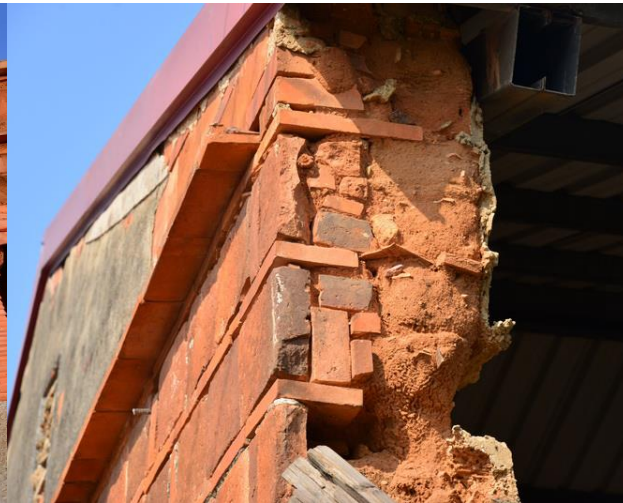
brick and adobe wall

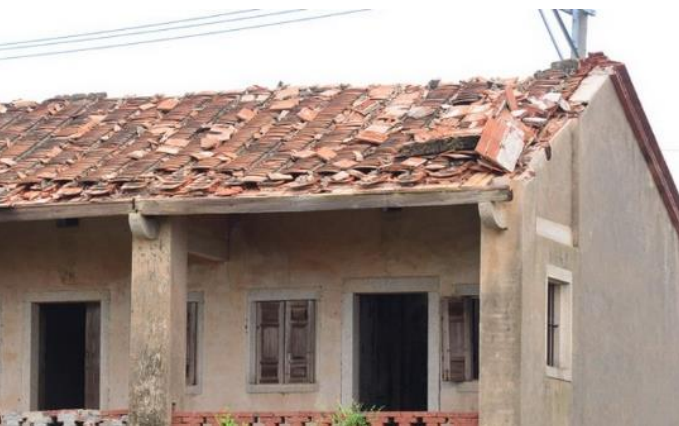
❖ **Loosened or fractured tiles:**

Red clay tiles will loosen up or break, causing rain water to enter the structure.

Loosened roof tiles caused by windstorm

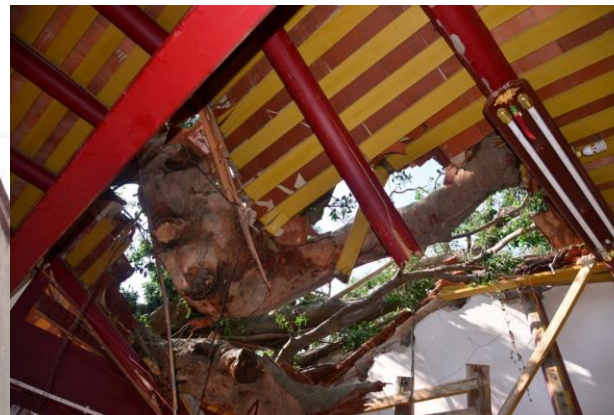
❖ **Roof collapse:**

A roof may collapse when it is hit by trees that are uprooted by the typhoon.

Fallen banyan crashed the roof

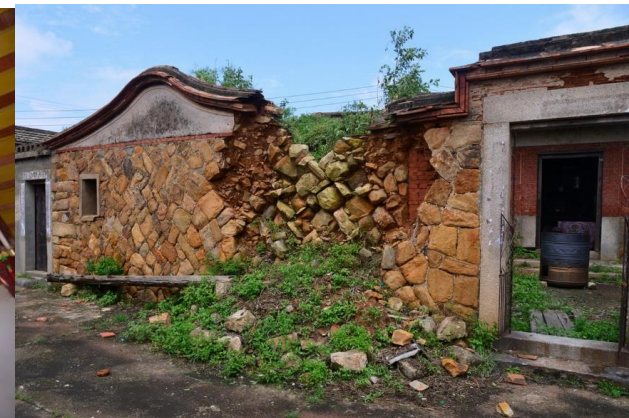
❖ **Disintegration of walls:**

Brick and clay walls are likely to disintegrate when exposed to strong winds.

Disintegration of wall

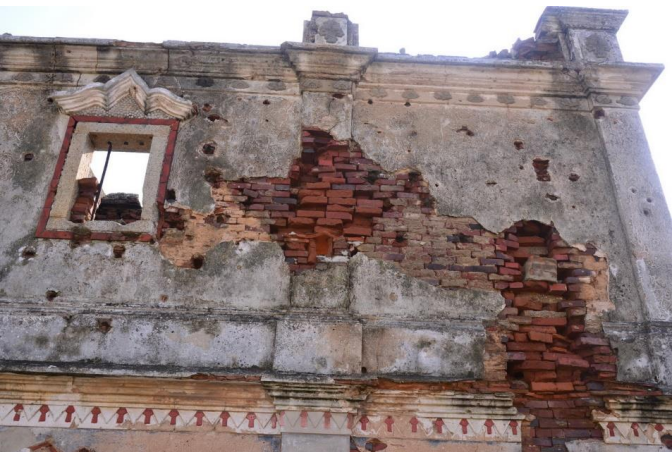
- ❖ **Deterioration of plaster walls:** The strong wind of Typhoon Meranti caused the surface of many buildings to peel, exposing the internal structure to rain.
- ❖ **Damage to decorative and architectural elements**
- ❖ **Doors, windows, and lighting fixtures.**
- ❖ **Environmental damage:** This includes damage to the surroundings of historical buildings, for instance if a giant banyan tree next to a historic building were to collapse.

Deterioration of plaster walls

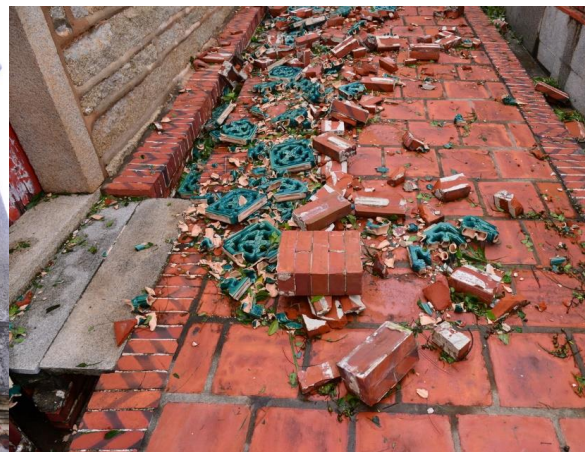
Fragments of a crumbled parapet

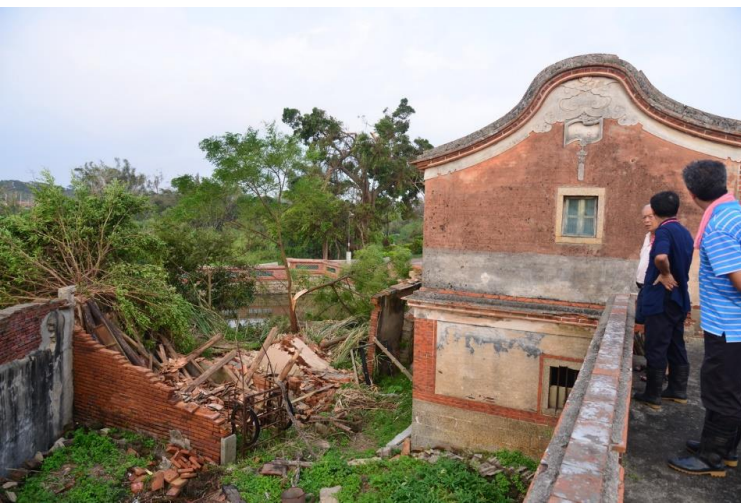
Collapsed roof

❖ **Phase I:** Preliminary Review, quick review in three days.

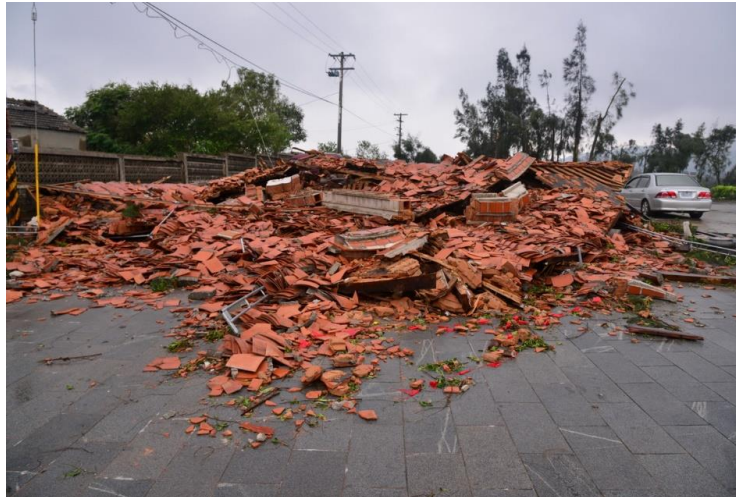
Collapsed roof

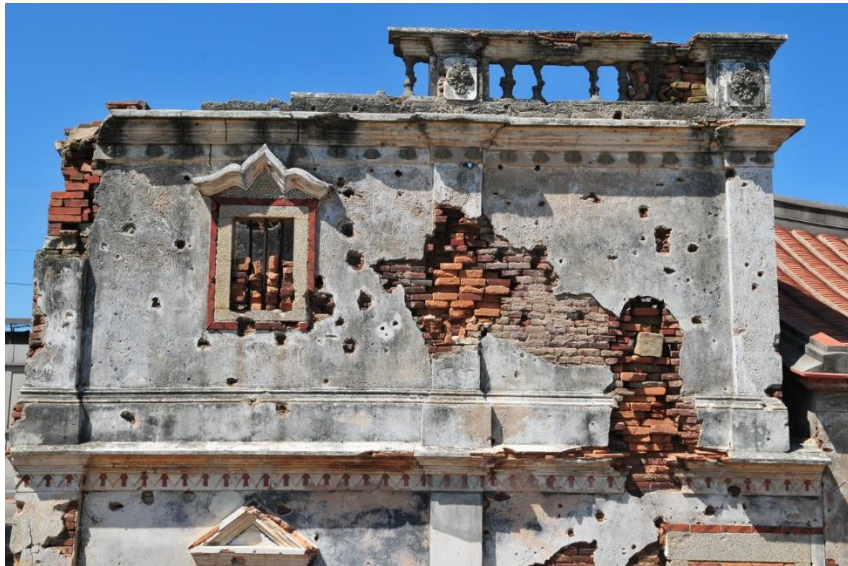
Before Typhoon Meranti

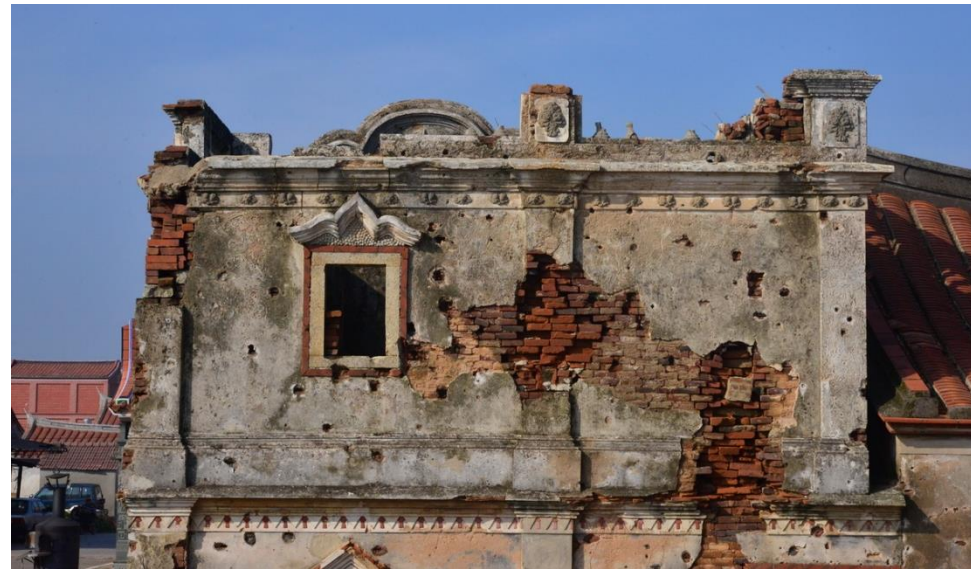
After Typhoon Meranti

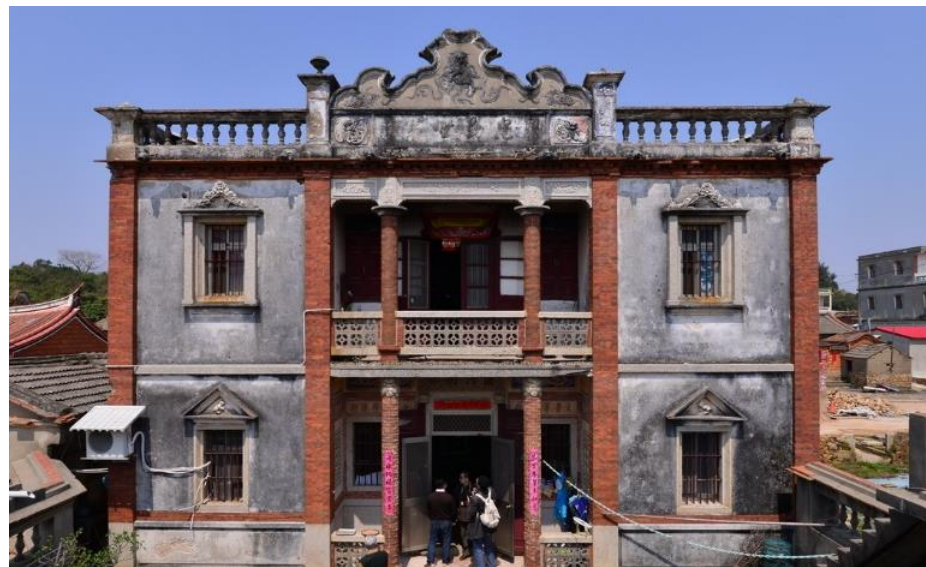
Before Typhoon Meranti

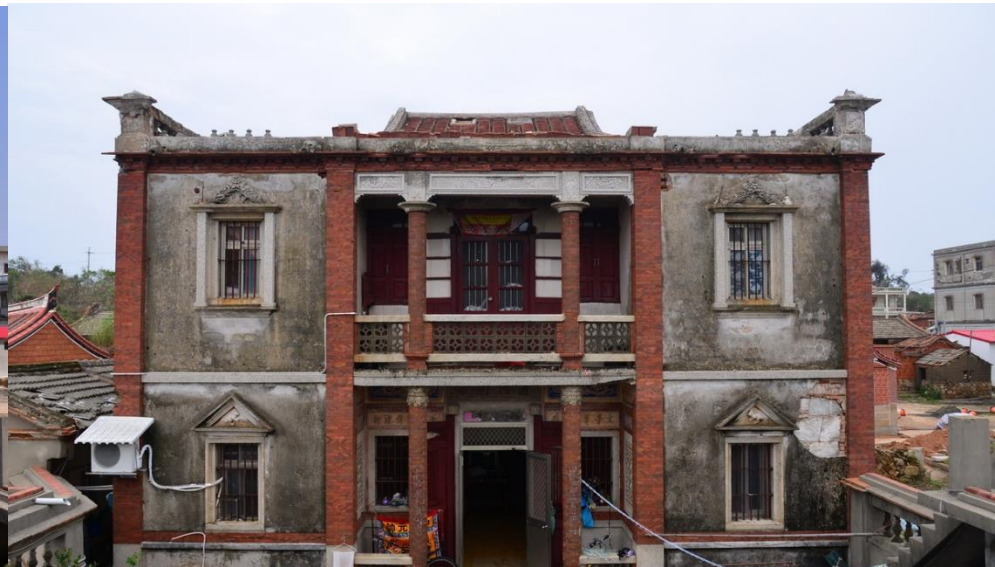
After Typhoon Meranti
